REVISED FIELD ADVISORY
Supersedes RegO Field Advisory Issued on February 3, 2017

L7579 1-3/4" X 1-1/4" MNPT Filler Valve
Date Codes 8B16 to 1C17

Product Information Bulletin – L7579 Date Code 8B16 to 1C17 Rework

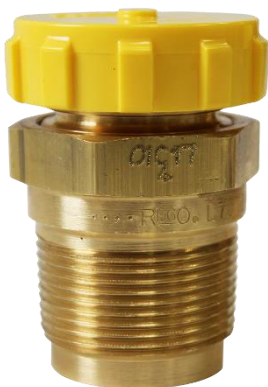
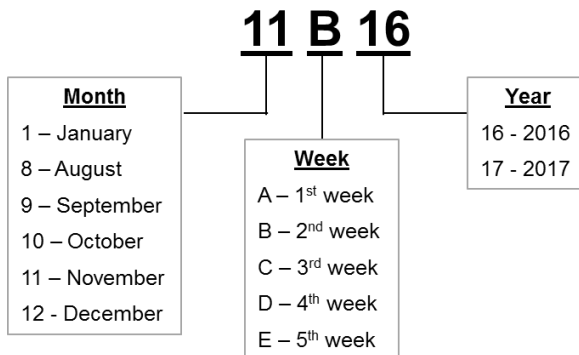
Date Code Identification

The dates of manufacture of the valves covered by this field advisory are August second week 2016 (8B16) to January third week 2017 (1C17).

1. We advise that you use a 3179 Filler Valve Adapter whenever you fill through an affected L7579 fill valve with date codes of 8B16 to 1C17, which is consistent with best industry practices for safety during every fill operation. If for some reason you did not use a 3179B fill adapter and have an issue disconnecting from any fill operation, please exercise extreme caution and follow your company procedures to prevent an accident.

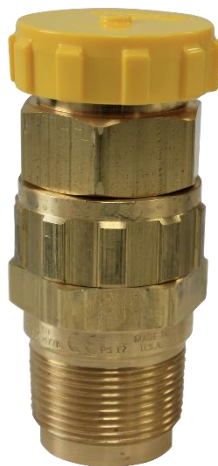
**L7579 with 3179B
adapter installed.**

It is a best practice to use filler hose adapters like the 3179B when conducting any filling operation into a 1-3/4" ACME filler valve. When a filler hose adapter is attached to the hose end valve connection during the filling process and there is a problem disconnecting due to leakage through the upper check, the 3179B or other type filler hose adapters can remain on the subject filler valve. This will allow the delivery person to safely disconnect the hose end valve from the filler hose adapter which will remain connected to the subject filler valve leak free.

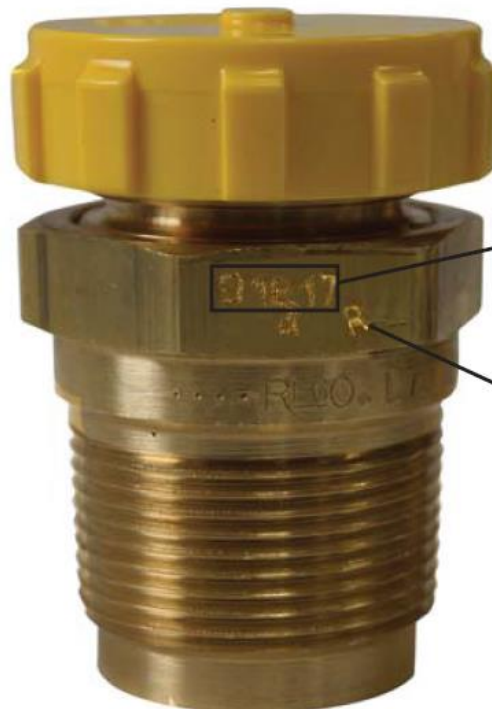
Reworked L7579

Date Code
(01B17)

NOTE:
The R stamp denoting rework can be located anywhere on the wrench flat where the date code is located.

Please be advised we are reworking new/never installed L7579 filler valves with date codes of 8B16 to 1C17 covered by the February 3, 2017 field advisory. The rework manufacturing process will revert the product back to the previous revision prior to August second week 2016. This will make the valve no longer applicable to the field advisory. The reworked valves will have an “R” (for reworked) stamped near the date code.
